Field Report for Airborne Data Collected In Support of US EPA Region VI Intercontinental Terminals Company LLC Fire 20 March 2019

Data Results Flight 4, 20 March 2019

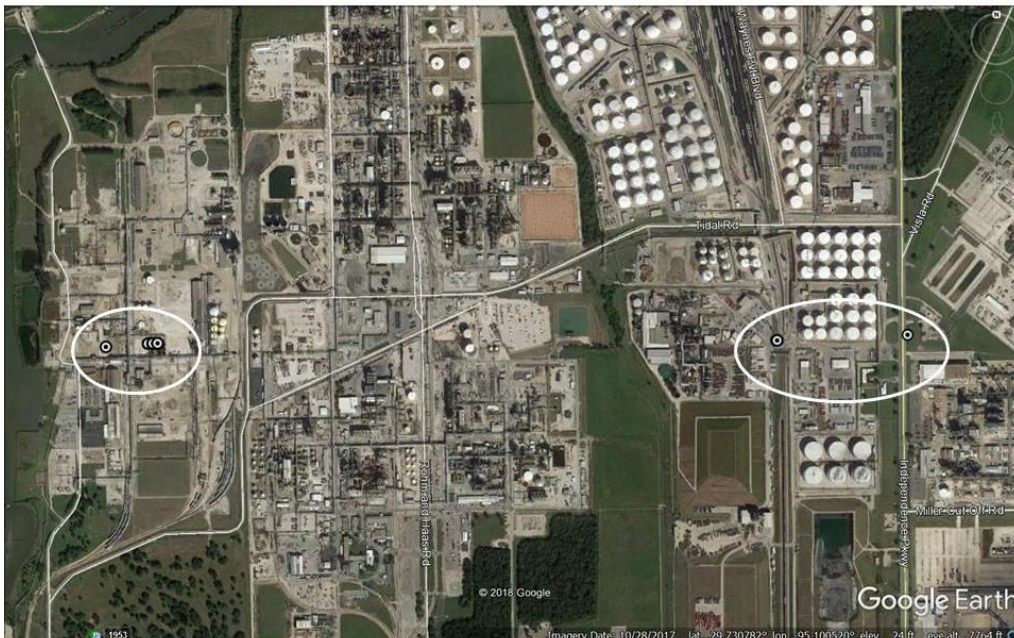
An examination of FTIR data collected on this mission showed low level detection west and south of the tank farm (Figure 5). Detections west of the farm include acetone (0.283ppm) and SO₂ (0.653 ppm). Based on the wind direction these detections are likely being transported into the area and are not associated with the former fire. Detections observed south of the tank farm include isobutylene (0.284 ppm) and isoprene (0.098 ppm) and may be associated with normal compounds in the urban air.

Figure 5: ITC Fire, Chemical Detection Locations – 20 March 2019

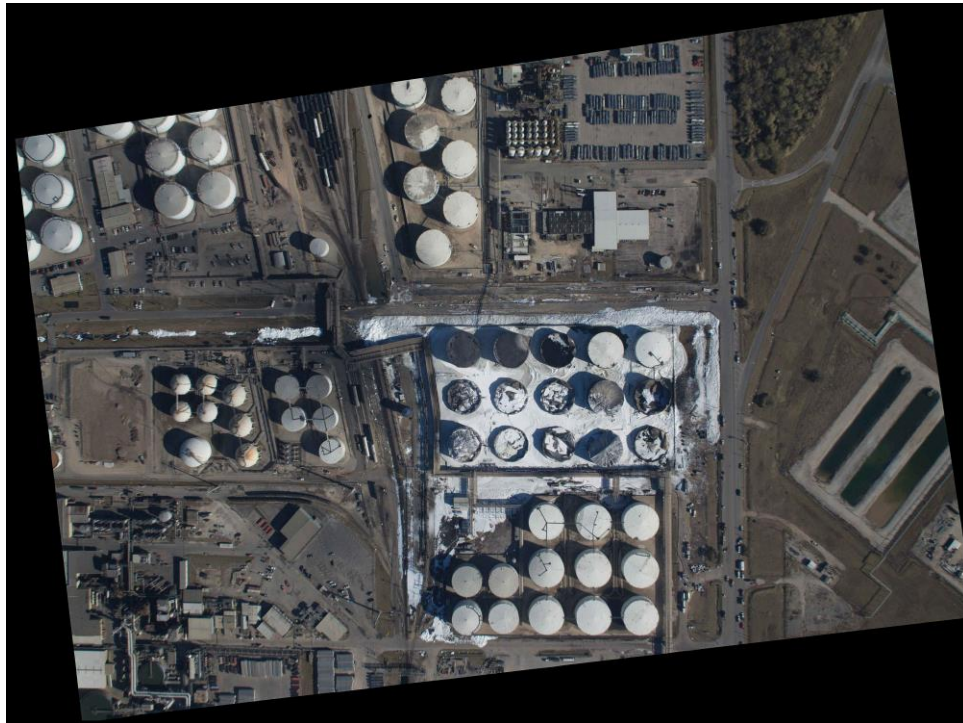
A full set of high resolution aerial digital photography were collected as part of the flight. Figure 6 shows a representative overhead image collected as part of each pass. As evident in the image, the fires associated with the tank farm are absent. In addition, the secondary containment area of the tank farm appears to be filled with a white substance. Figure 7 illustrates a typical oblique image. Both images confirm the finding that the fire has been extinguished and that the secondary containment is filled with a white substance.

Figure 6: Aerial Image of the ITC Fire, Flight 4

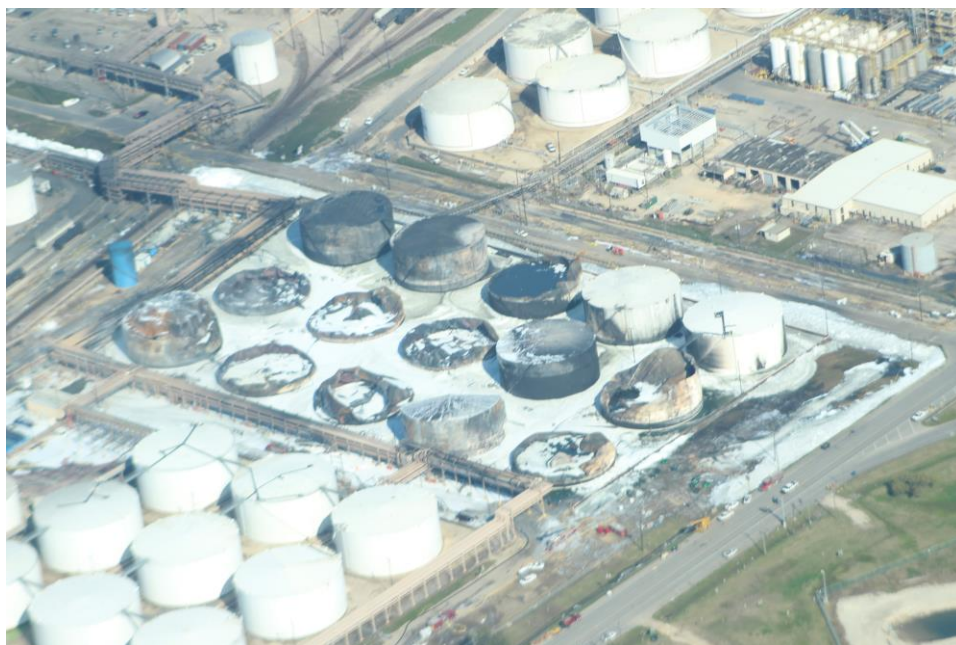
Figure 7: Oblique Image of the ITC Fire, Flight 4
